# New York State Department of Transportation

## Yellow Flag NB23U4W021

### Structure Information

Location: Span 206, Girder G19 at Pier 205

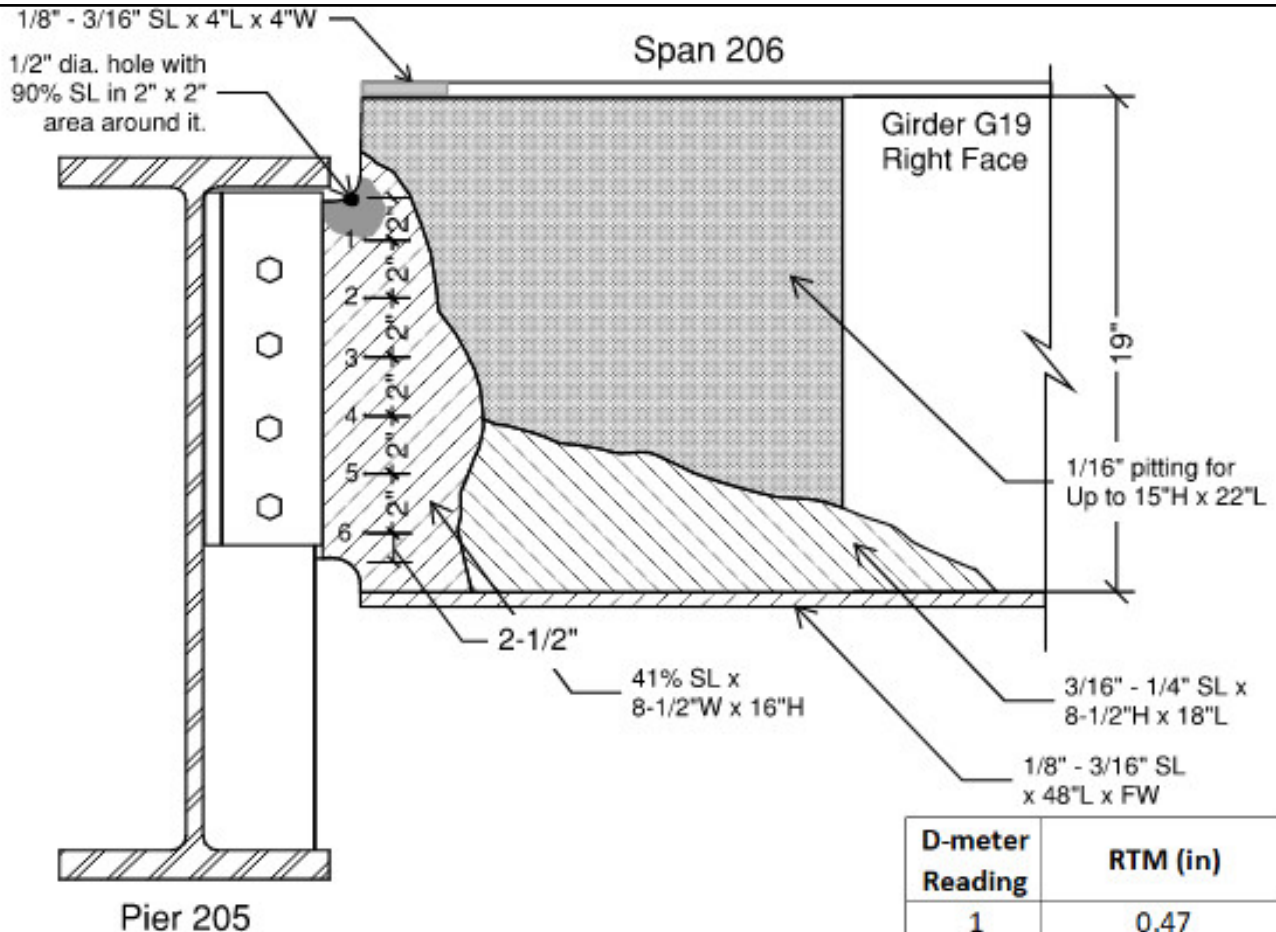
Photo Number: 2

Girder G19 web exhibits 41% overall section loss between upper cope and lower cope on the right face, along the connection angle. There of also a 1/2" diameter hole with 90% section loss in surrounding area of 2" x 2" right below upper cope. This 41% section loss is spreaded over an area of 16"H x 8-1/2"W along the connection angle. Adjacent to this, there is 3/16" to 1/4" section loss in lower web for 8-1/2"H x 18"L along bottom flange. Upper web on right face exhibits 1/16" pitting for up to 15"H x 22"L. Top flange on right side exhibits 1/8" to 3/16" section loss for 4"L x 4"W at the girder end.

**Section Loss Calculations:**

Original Girder Web Thickness = 0.62" (as measured in the field)

As Built shearing web area = 14.5" H x 0.62" T = 8.99 sq. in.

Average remaining web section =  $[(0.1 \times 0.62) \times 2"] + [0.47 \times 2"] + [0.45 \times 2"] + [0.47 \times 2"] + [0.5 \times 2"] + [0.347 \times 2"] + [0.3 \times 2.5"]$   
 = 5.348 sq. in.

Web section loss –  $((8.99 - 4.448)/8.99) \times 100\% = 40.51\%$  SAY = 41%

**SKETCH FOR YELLOW FLAG # NB23U4W021**  
**SPAN 206, GIRDER G19 AT PIER 205**  
**(LOOKING LEFT)**  
**N.T.S**

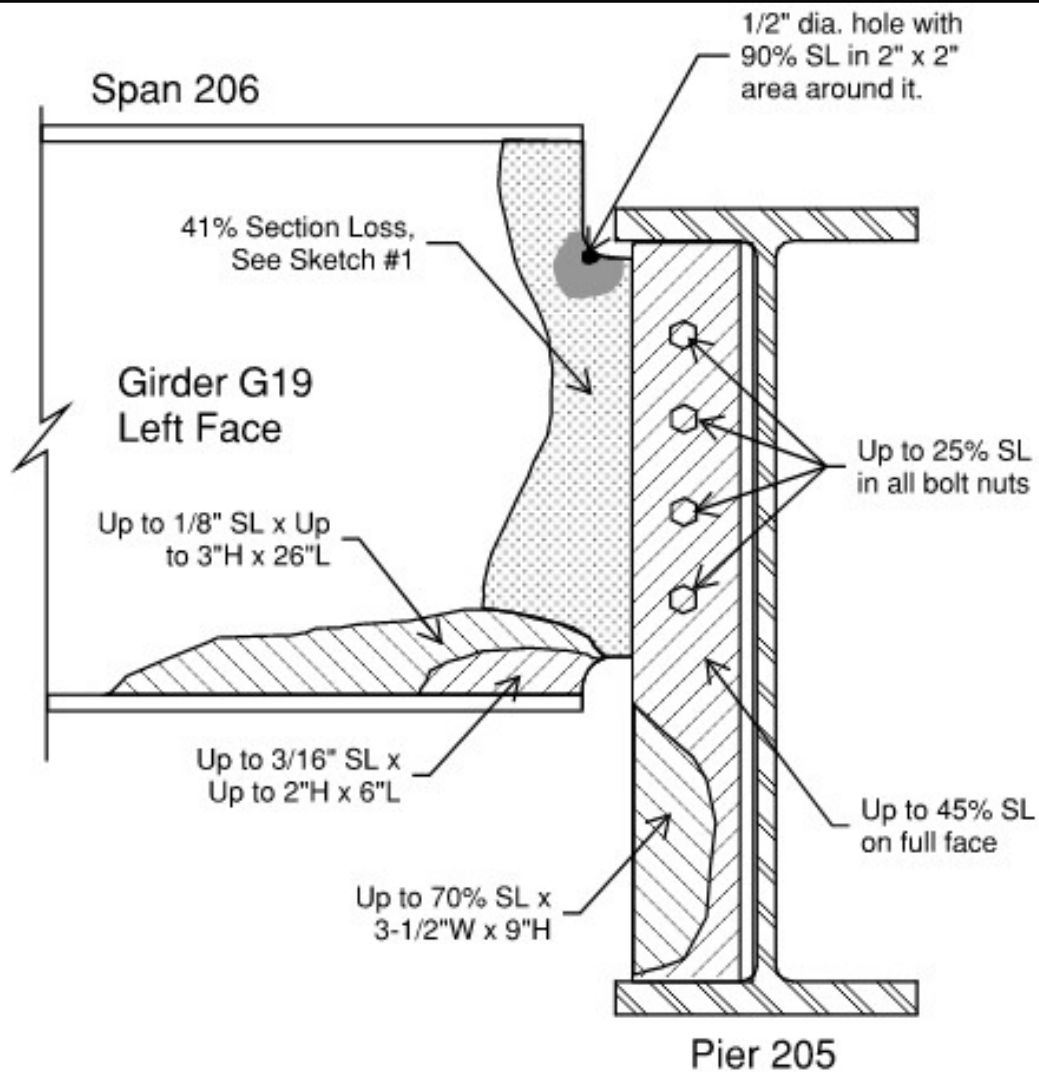
Photo Number: 3

Girder G19 lower web on left face exhibits up to 3/16" section loss for up to 2"H x 6"L along the bottom flange near bottom cope. Above this area, there is up to 1/8" section loss in area of Up to 3"H x 26"L. Stiffener angle on left side has an area of 3-1/2"W x 9"H with up to 70% section loss in lower portion of connecting leg. Remaining face of the connecting leg exhibits up to 45% section loss with up to 25% section loss in all 4 bolt nuts.

**SKETCH FOR YELLOW FLAG # NB23U4W021**  
**SPAN 206, GIRDER G19 AT PIER 205**  
**(LOOKING RIGHT)**  
**N.T.S**

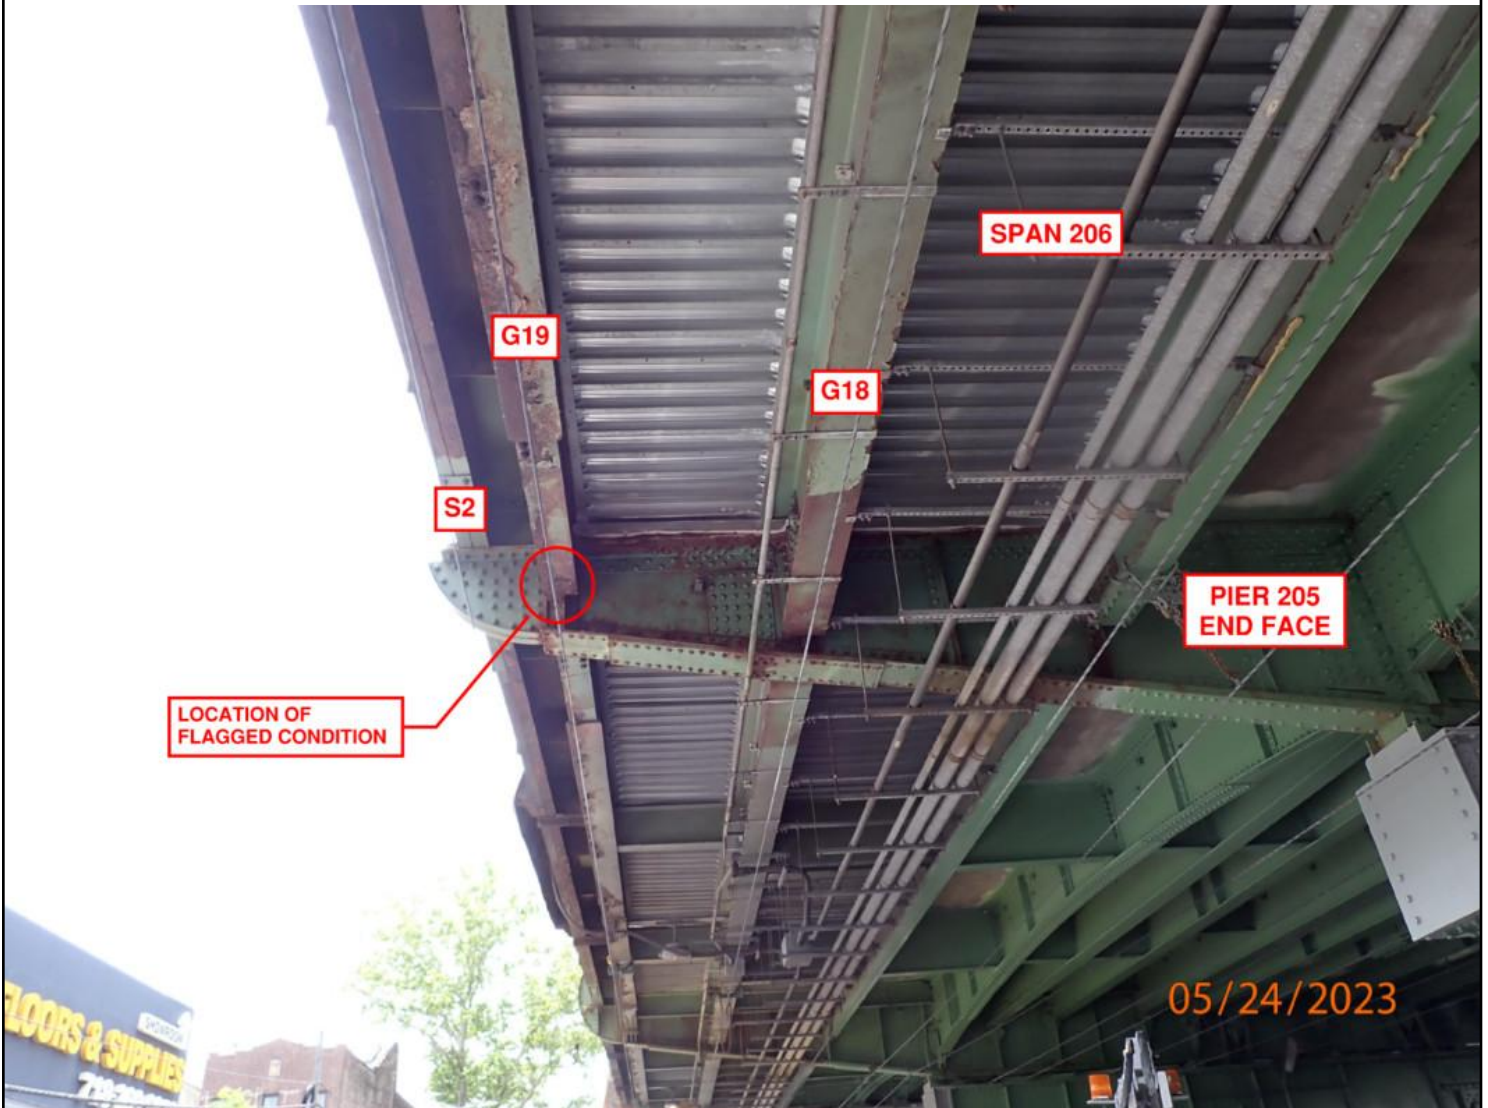
Photo Number: 4

**Attachment Description: General View of Flag Location. Looking Begin - Up**

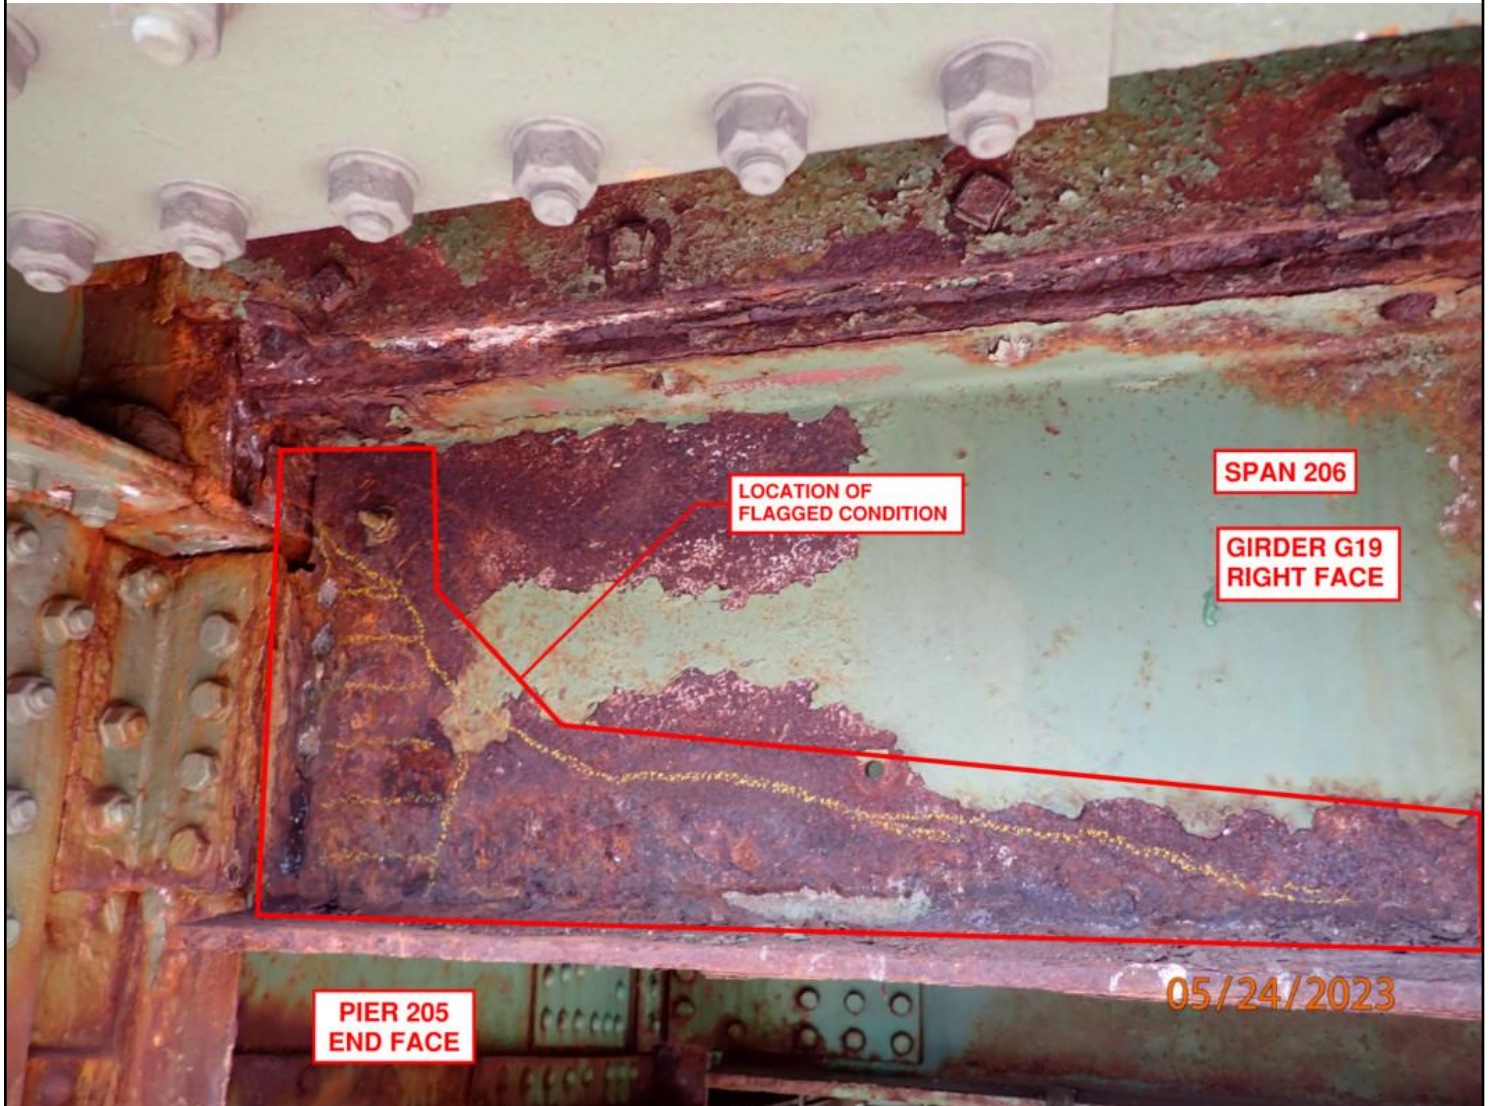
Photo Number: 5

**Attachment Description: General View of Flag Location on Right Face. Looking Begin - Left**

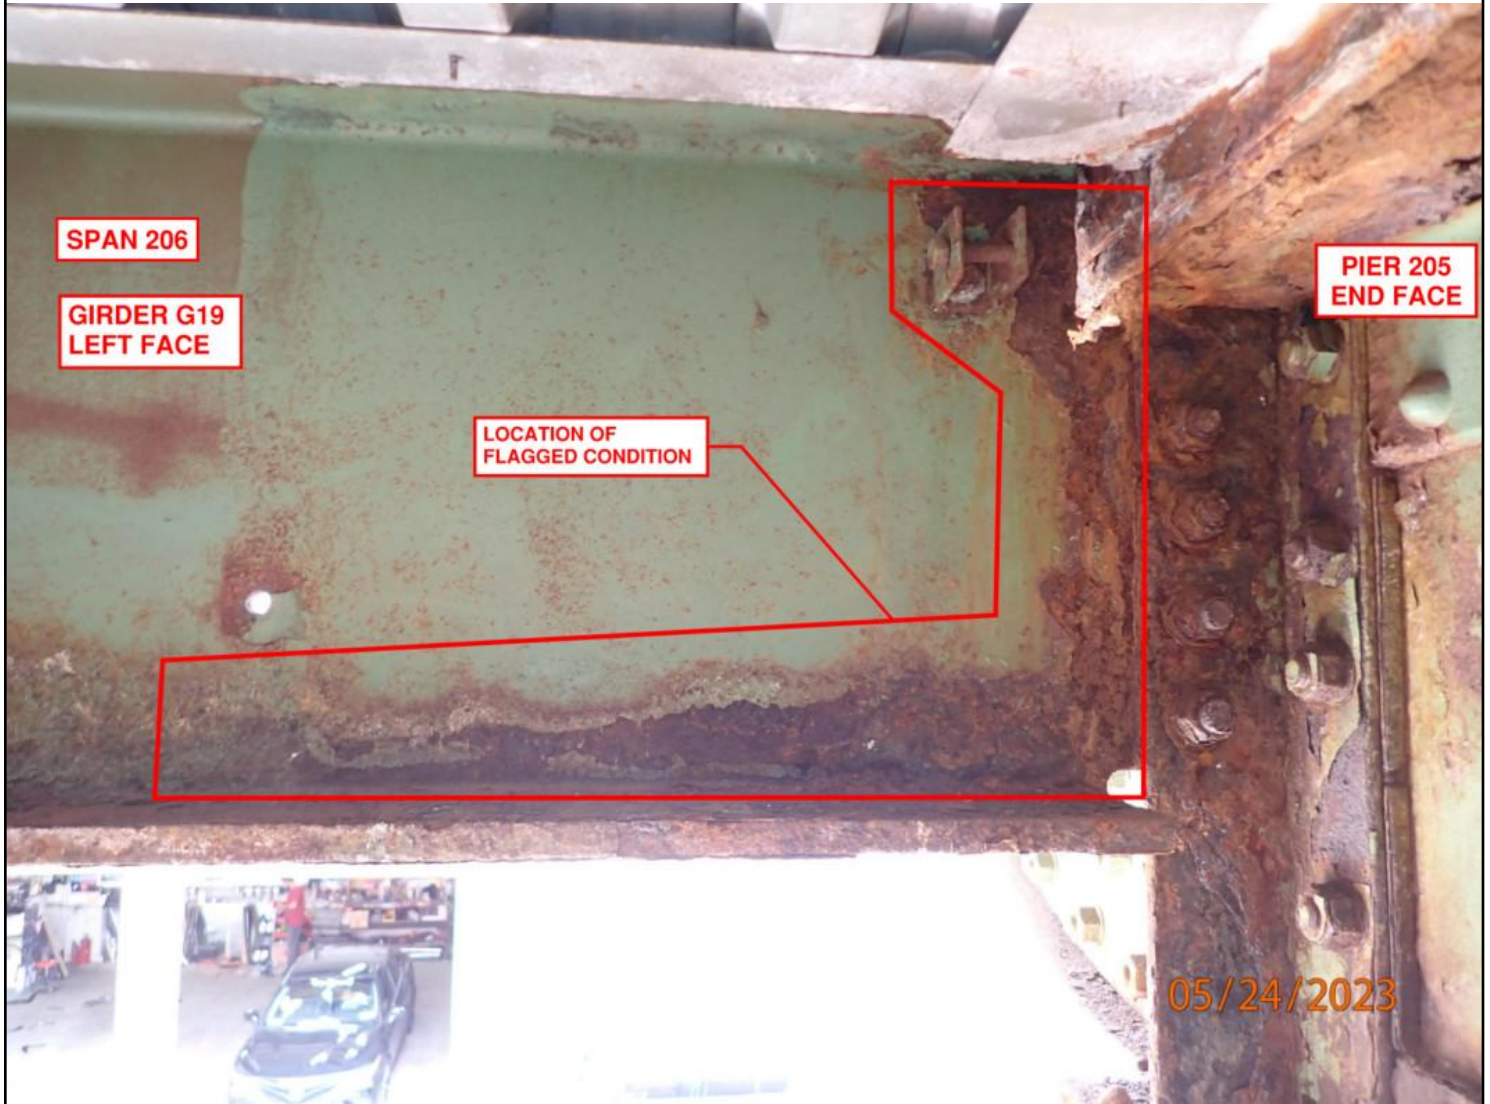
Photo Number: 6

**Attachment Description: General View of Flag Location on Left Face. Looking Begin - Right**

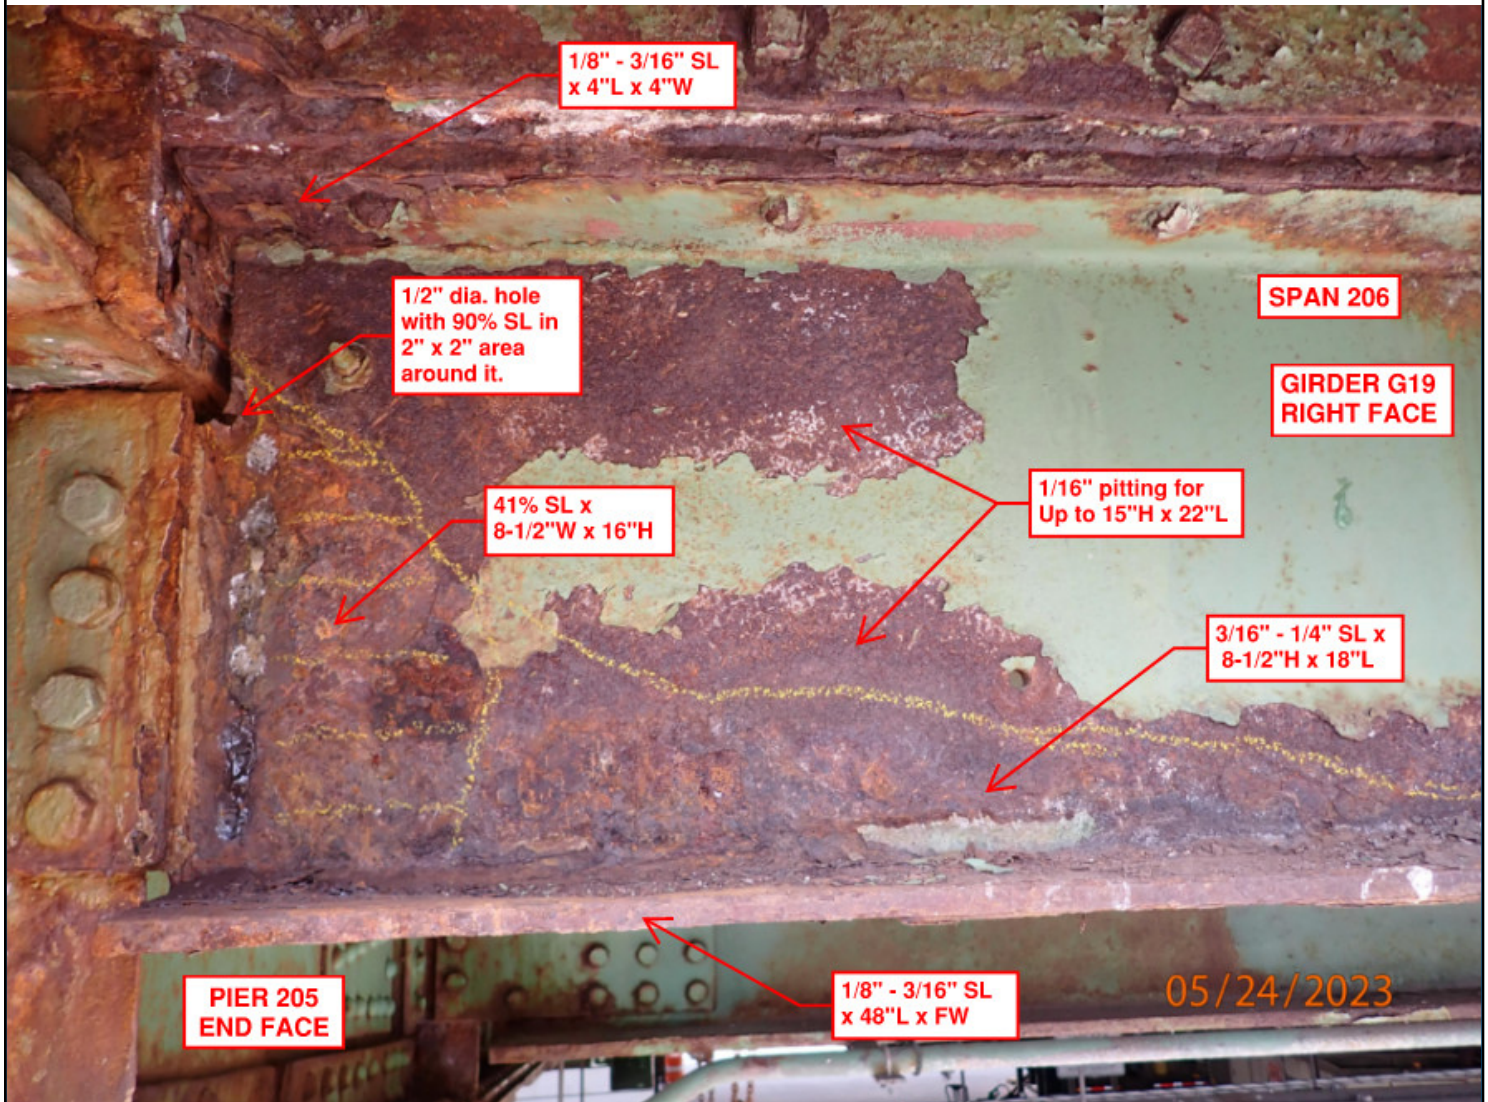
Photo Number: 7

**Attachment Description:** Girder G19 web exhibits 41% overall section loss between upper cope and lower cope on the right face, along the connection angle, with a 1/2" diameter hole and 90% section loss in surrounding area of 2" x 2" right below upper cope. Lower web has up to 1/4" section loss in lower web for 8-1/2"H x 18"L and upper web has 1/16" pitting for up to 15"H x 22"L. Looking Left.

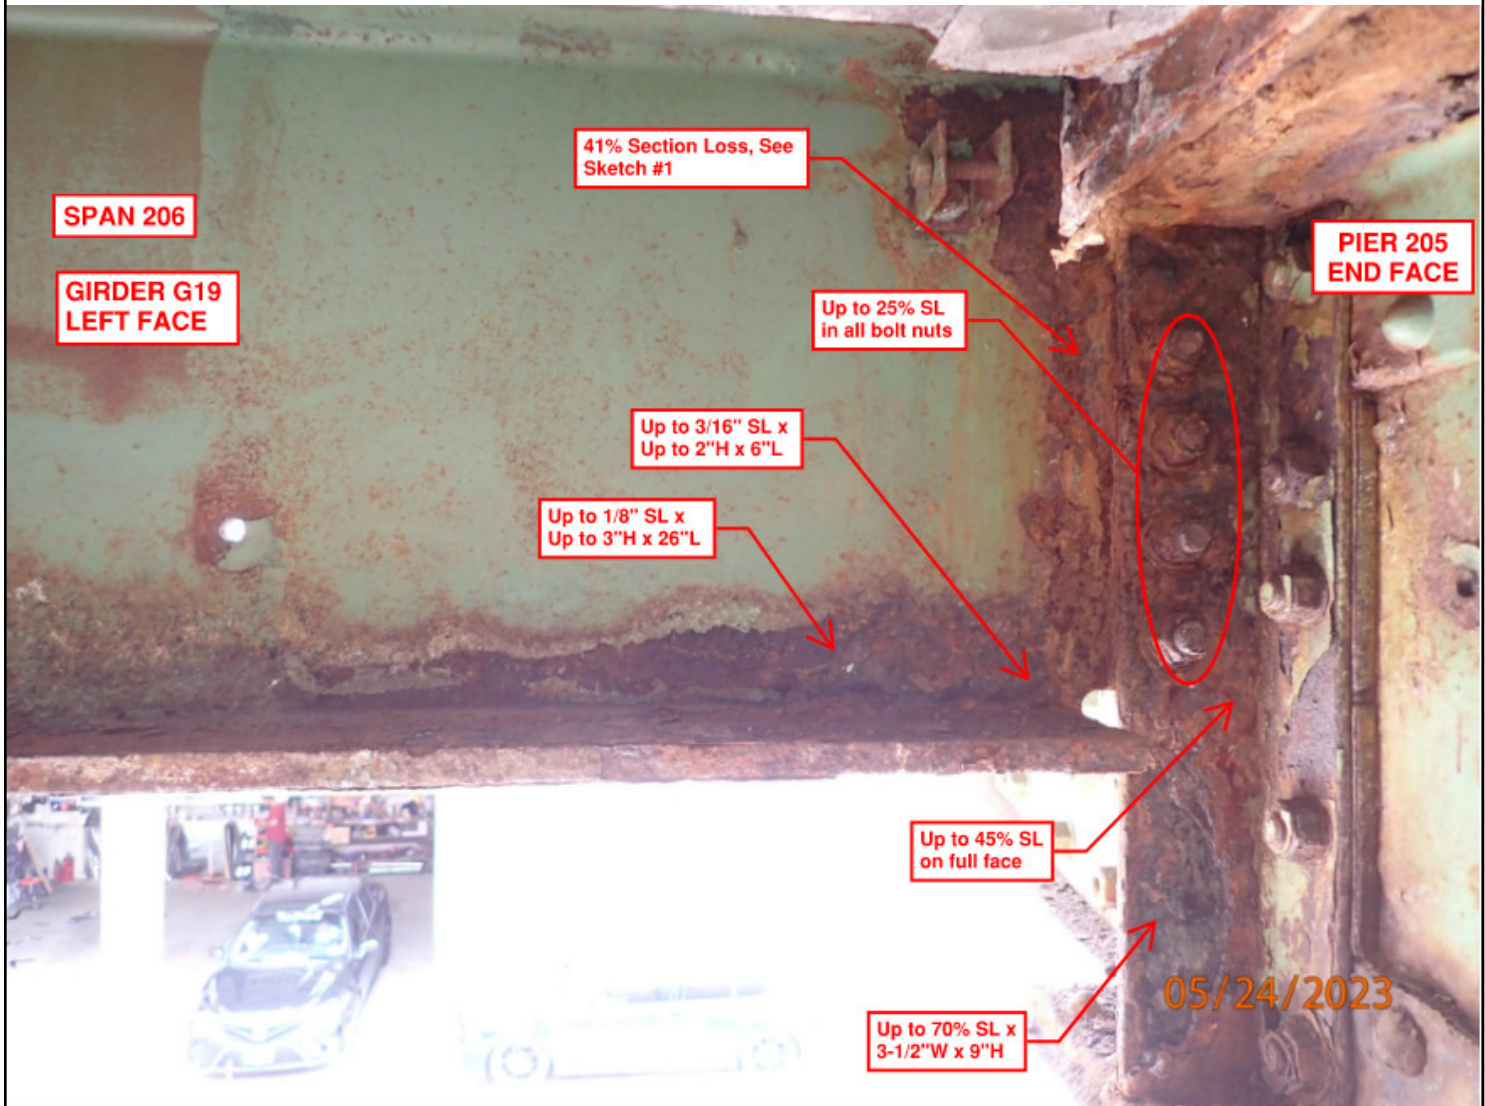
Photo Number: 8

**Attachment Description:** Girder G19 lower web on left face has up to 3/16" SL for up to 2"H x 6"L along the bottom flange and up to 1/8" SL in area of Up to 3"H x 26"L. Stiffener angle on left side has an area of 3-1/2"W x 9"H with up to 70% SL in lower portion of connecting leg. Remaining face of the connecting leg exhibits up to 45% SL with up to 25% section loss in all 4 bolt nuts. Looking Right.
